Built-in touchless tap

Qtoo collection

Product	250mm built-in infrared touchless tap
Tender text	QTOO collection, built-in touchless tap. Manufactured in the highest quality marine grade AISI 316 stainless steel, protecting against high levels of corrosion and securing cleaner drinking and utility water.
Re — handle®	
Re-handle your product here	Re-handle® this product (does not apply to coated items) to prolong its life span up to 100 years, lowering the Global Warming potential (CO2) between 54-91% depending on the product.
Product specification	Spout projection: 250mm (9 27/32")

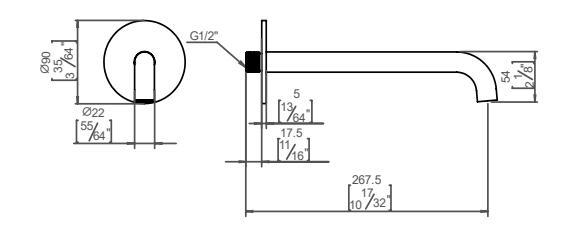
Rose diameter: Ø90mm (3 1/2")
	Build in depth: 69mm (2 3/4")
:	Spout: preinstalled 5,7 l/min (1,5 gpm) aerator
	(contact sellers for other options)
	Comfort time out 2 sec.
:	Security time out 30 sec.
	Automatic rinse cycle (deactivated)
	Always secure min. 140mm - 5 1/2" distance from
	aerator to washbasin waste
1	Use with Flexbox QSF01 and connecter QS3400
	Temperature control in Flexbox
	Max. work pressure 8 bar
	Including 920mm - 36 7/32" cable
	Lead free compliant
	Material: Marine grade AISI 316 stainless steel
	20-vear warranty (5 years for coated items)
