Built-in touchless tap

QST3190M

Product 190mm built-in infrared touchless tap

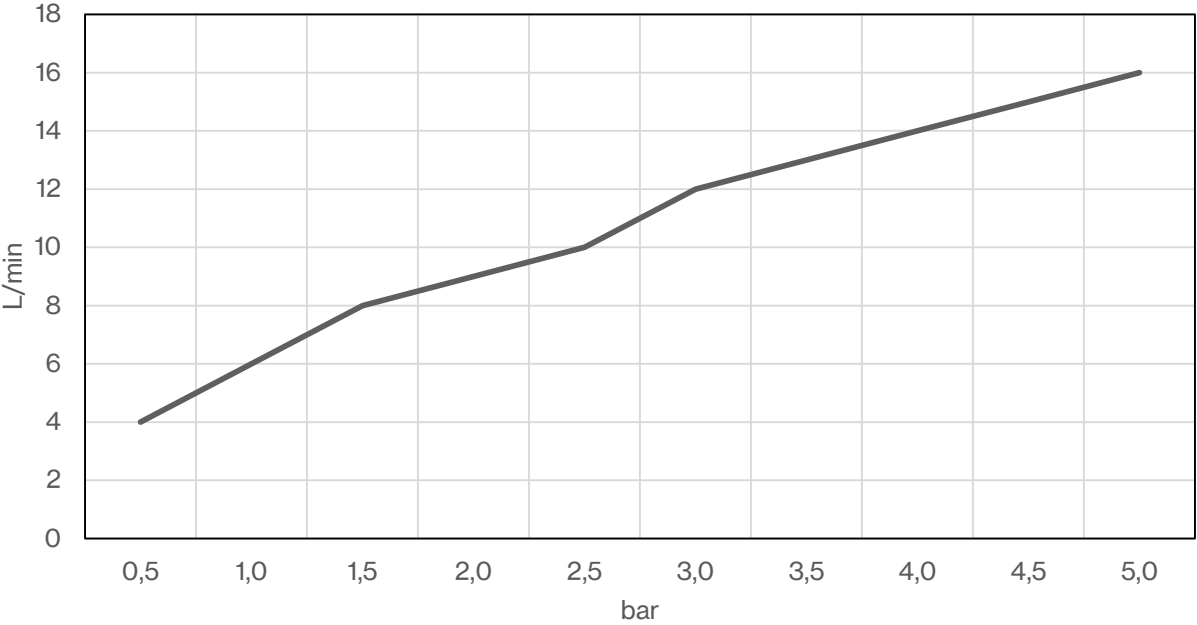
QST3190 flow rate (without aerator)
